Midgeland Farm  
Midgeland Road, Marton, Blackpool, Lancashire:  
Historic Buildings Assessment

July 2009

### Historic Buildings Assessment

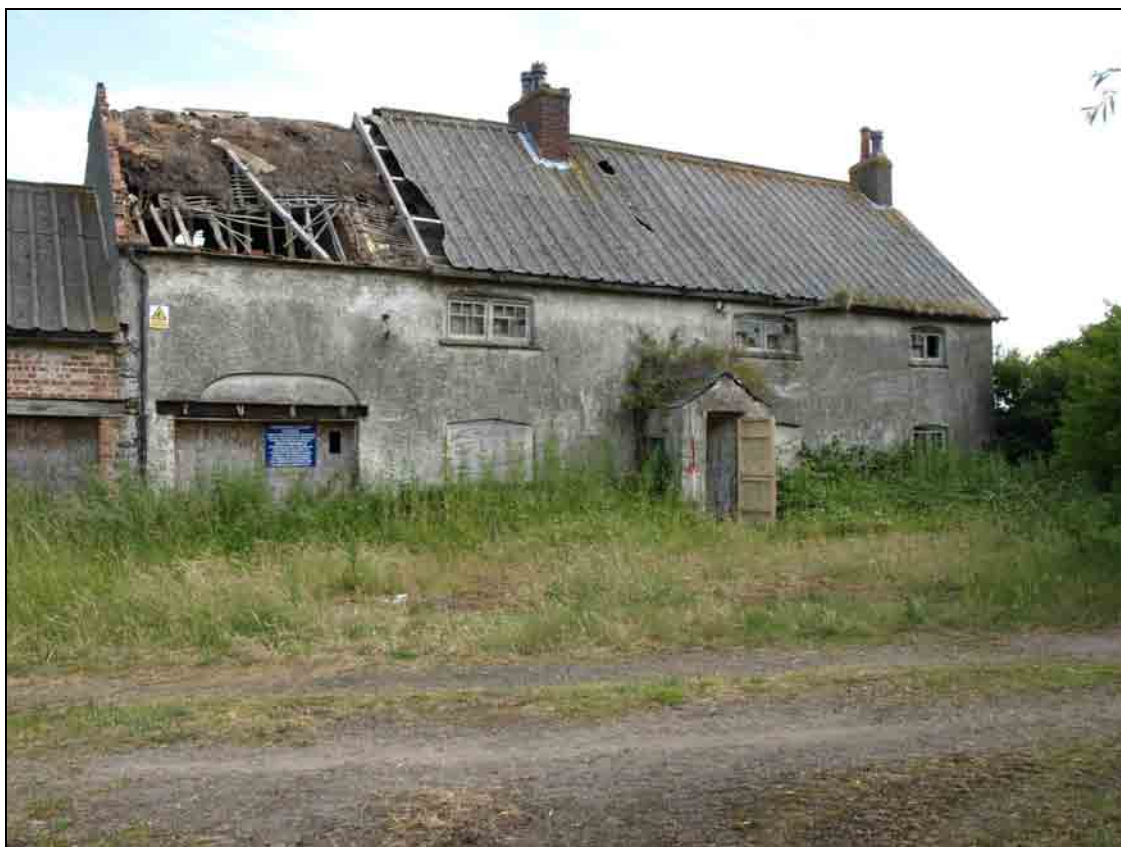
Photo 1: Buildings 1 and 1a: house and former stable, front elevation

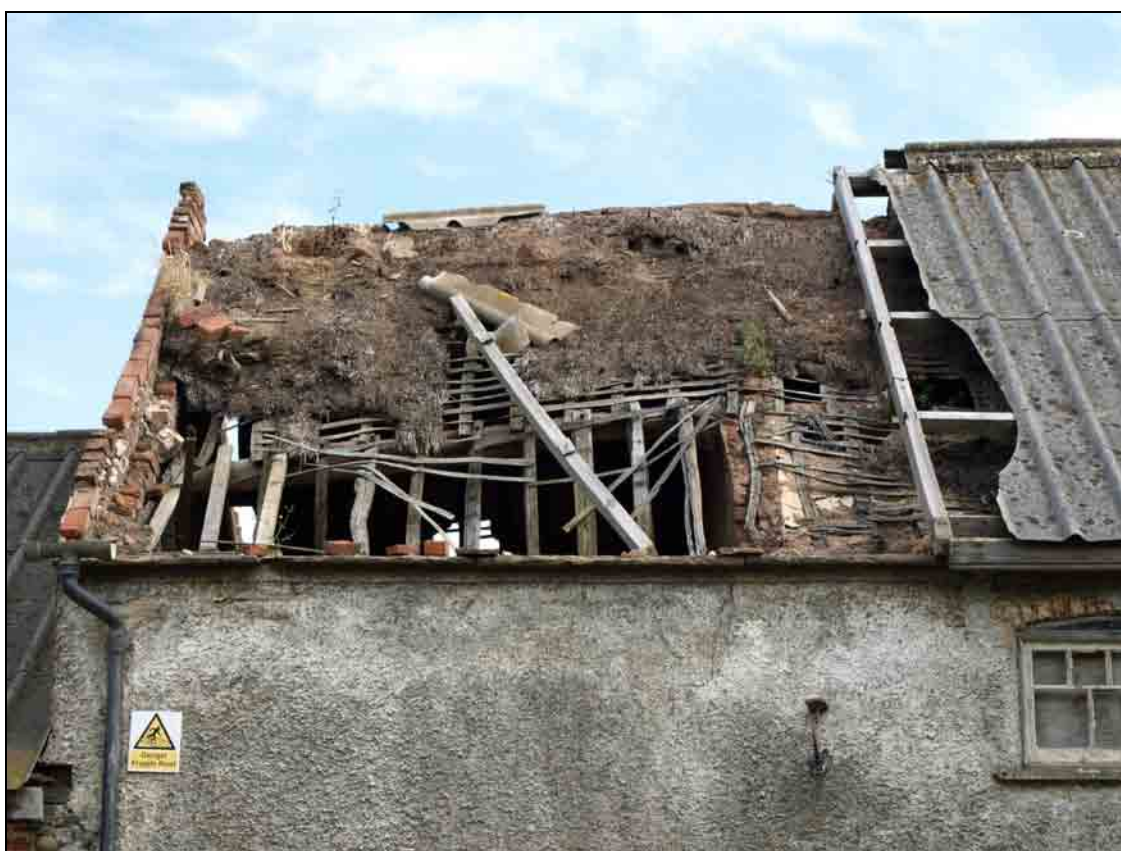
thatched, probably with straw, but has been overlaid with a timber framework supporting asbestos cement sheeting, perhaps in the 1950s, so that only where this later covering has been blown off is the thatch visible.

Photo 2: Detail of surviving thatch on Building 1

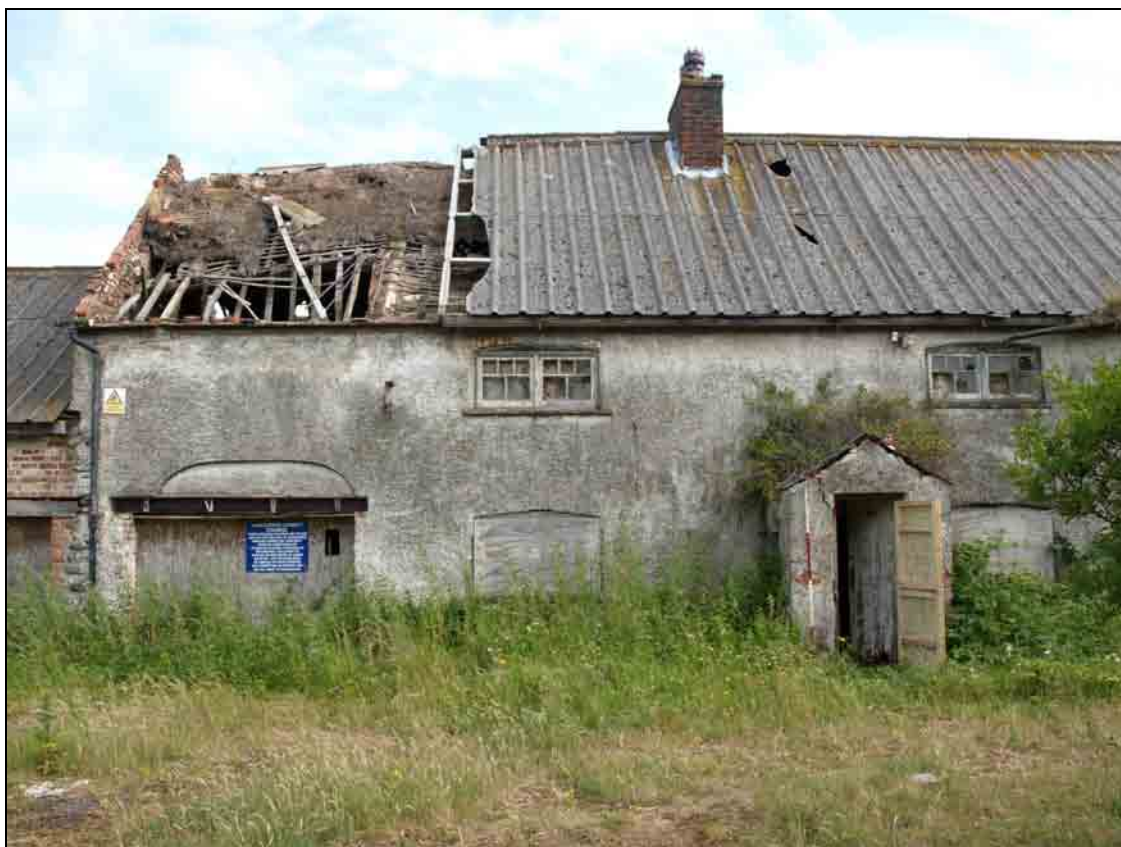
Photo 3: Buildings 1 and 1a: west part of house and entrance to former stable

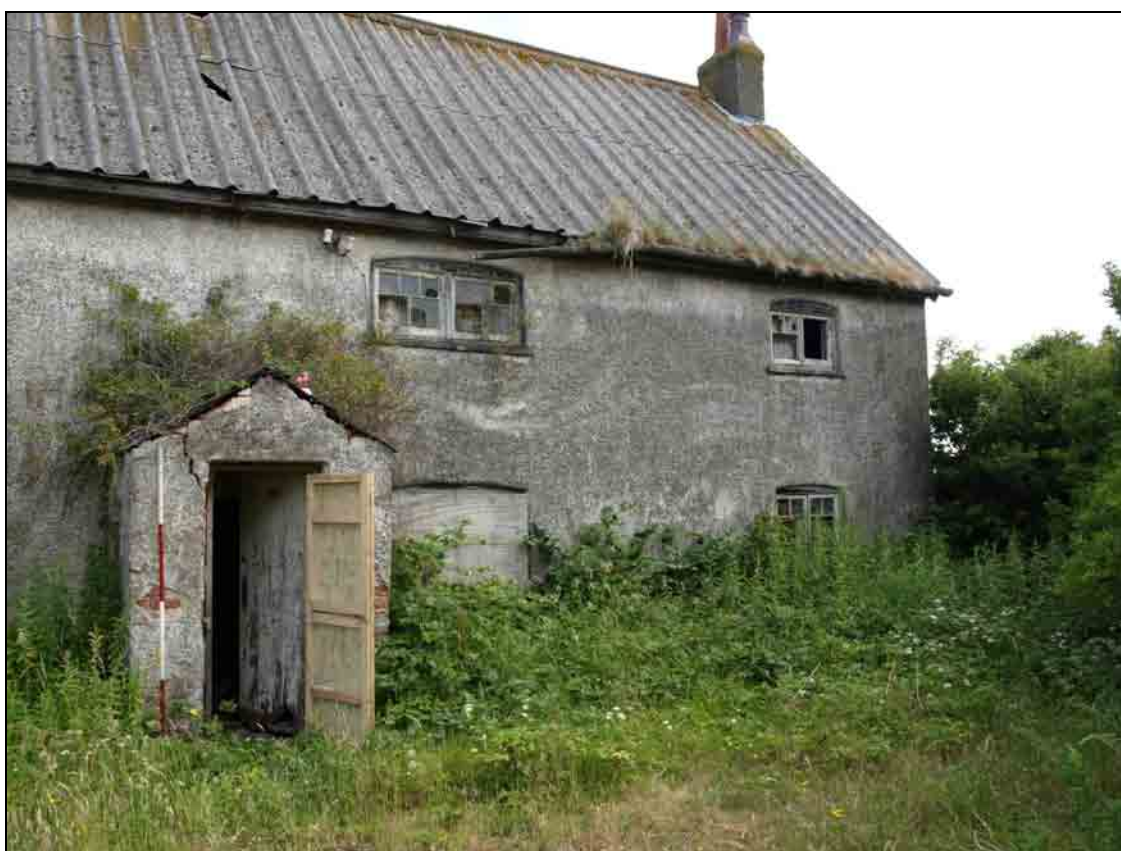
Photo 4: Building 1: east part of house

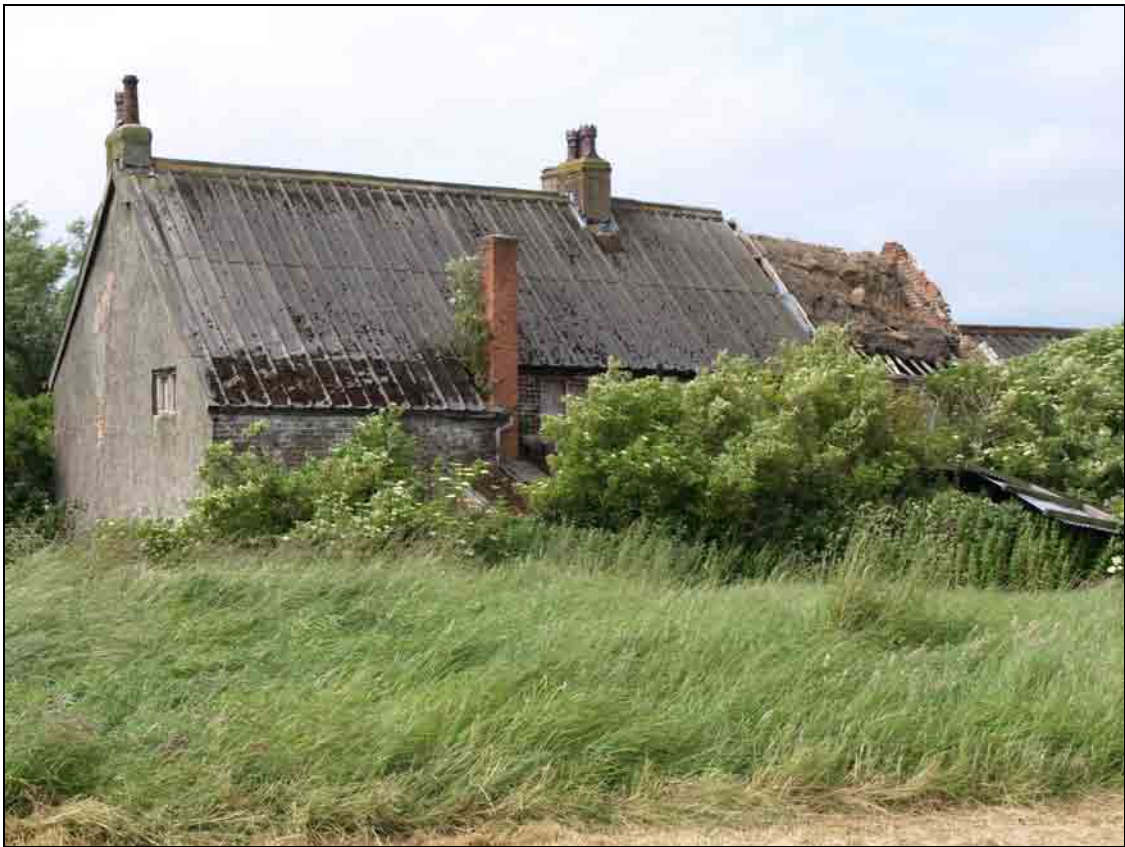
Photo 5: Building 1: house, rear elevation

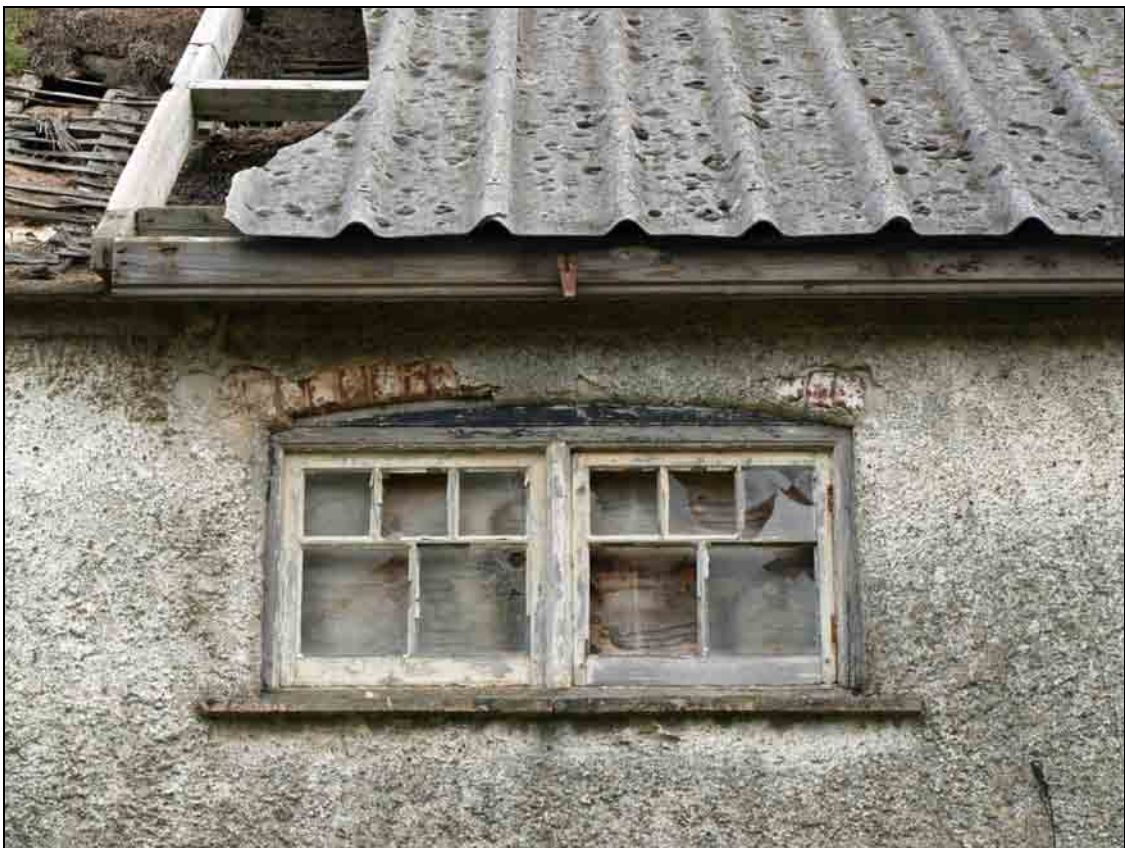
Photo 6: Building 1: typical window in front elevation

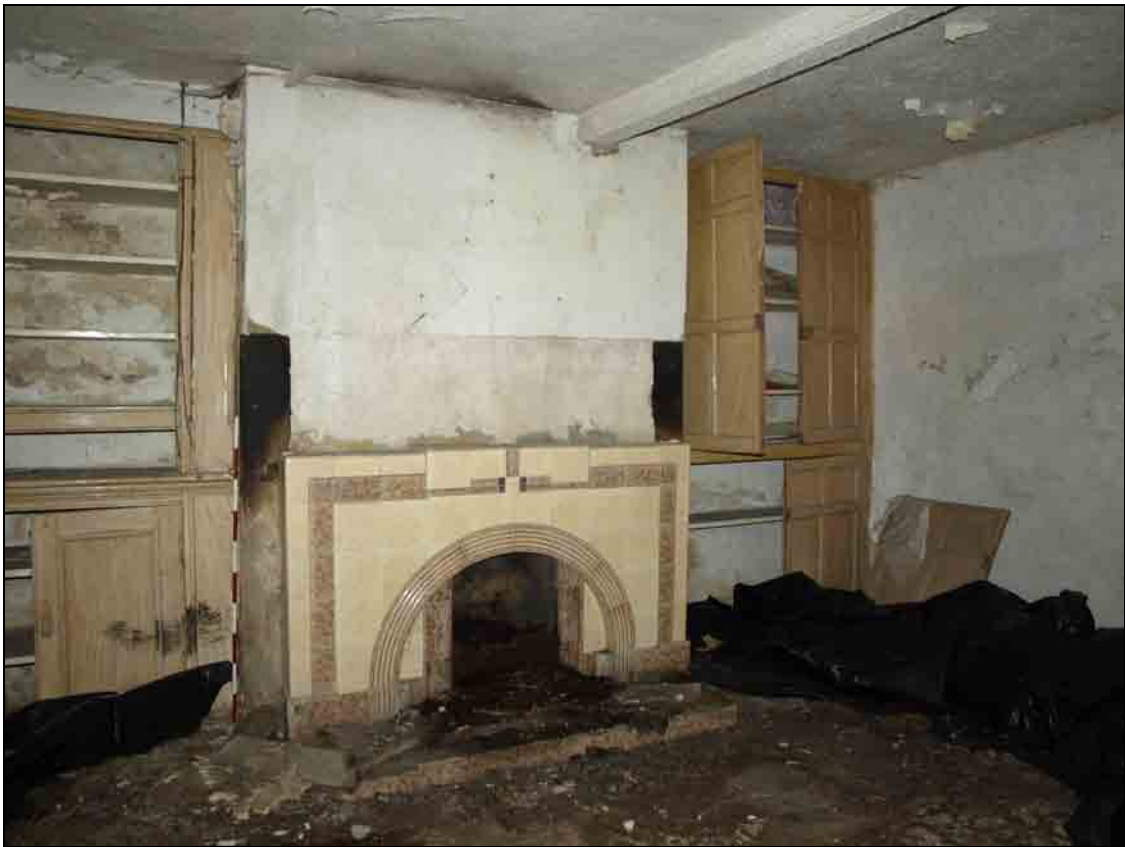
Photo 7: Building 1: housebody in central part of house (from the south-east)

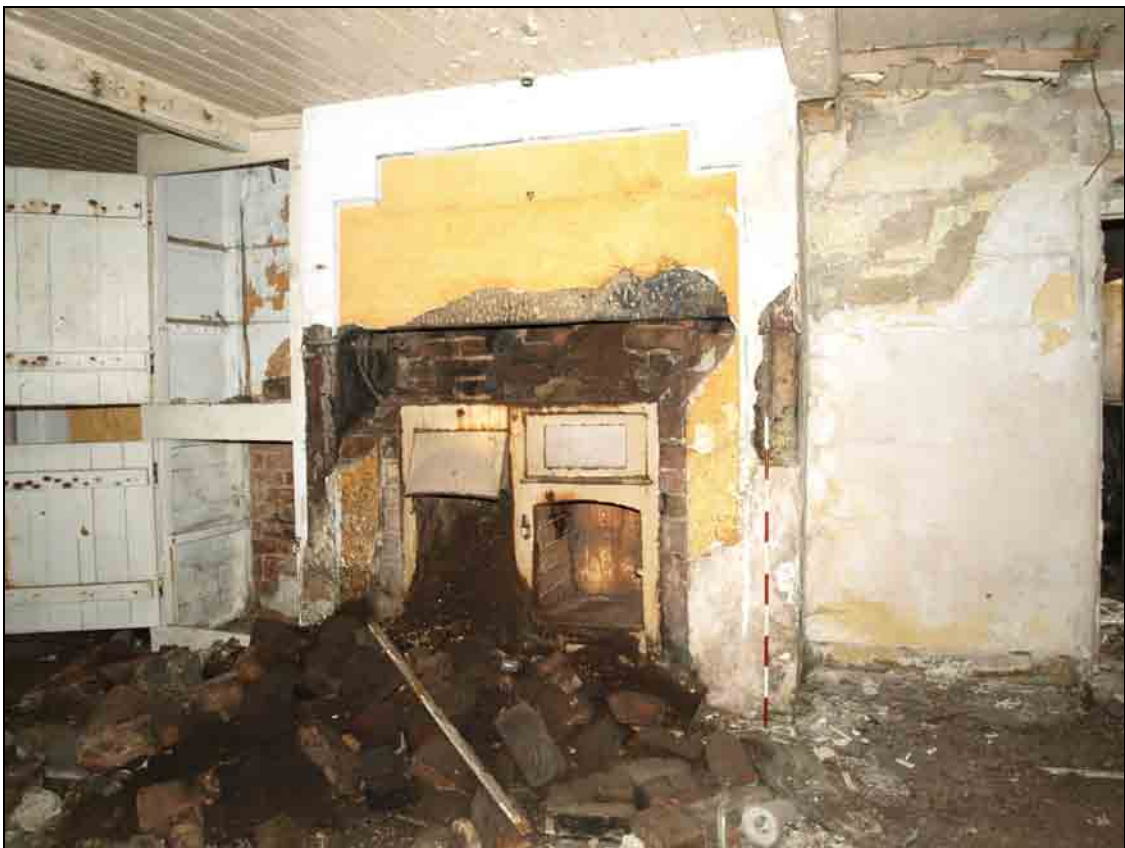
Photo 8: Building 1: kitchen in west part of house (from the west)

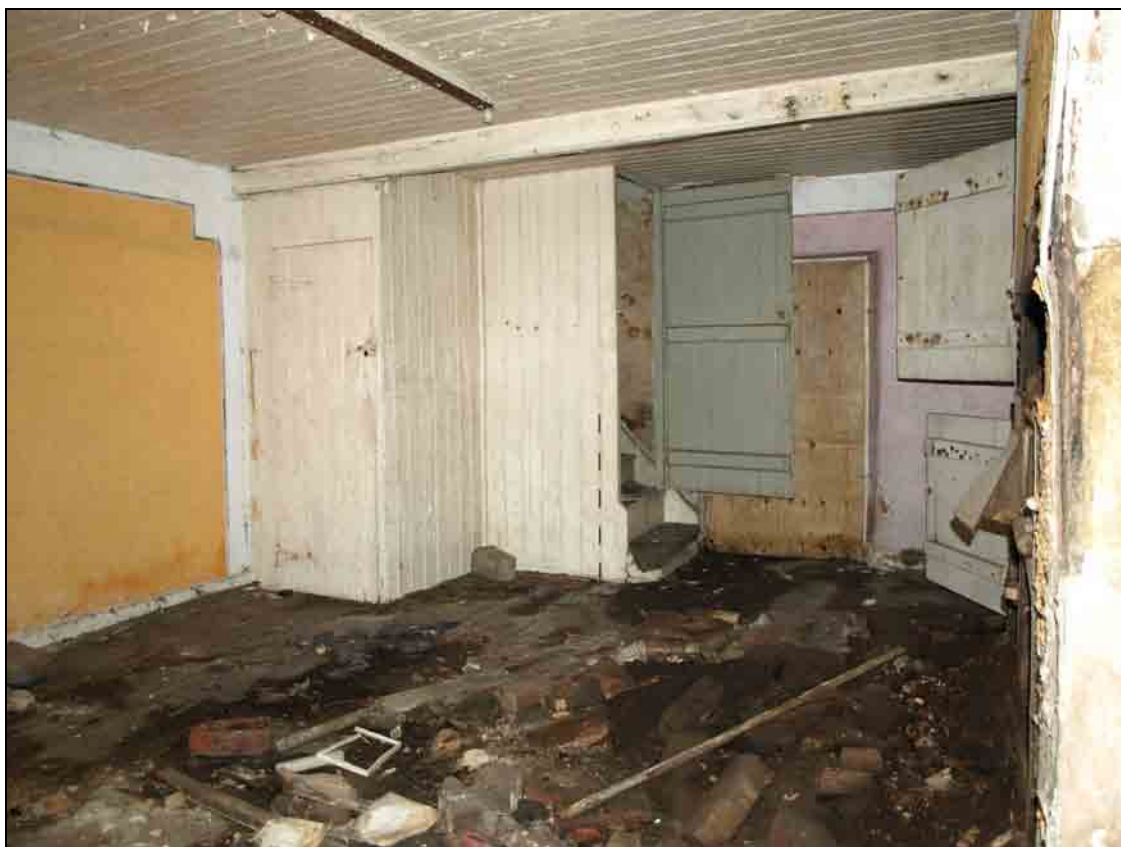
Photo 9: Building 1: kitchen in west part of house (from the south)

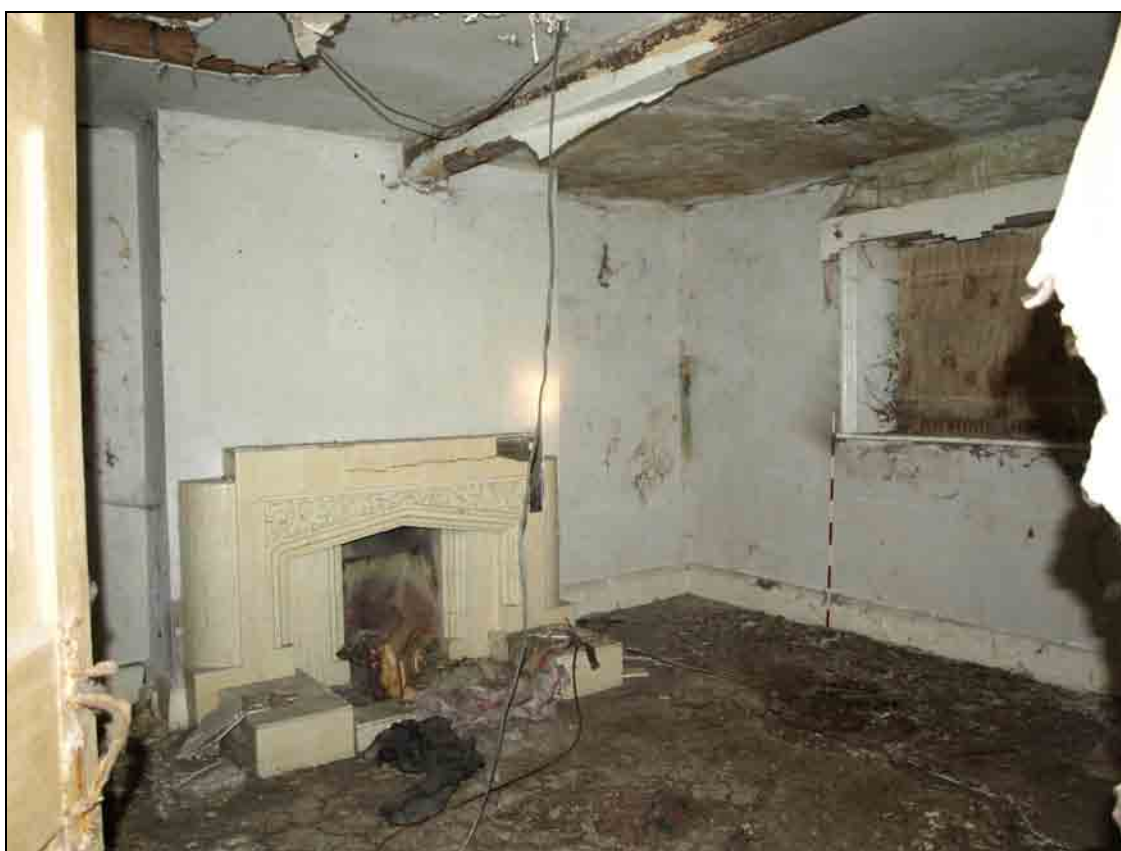
Photo 10: Building 1: parlour in east part of house (from the west)

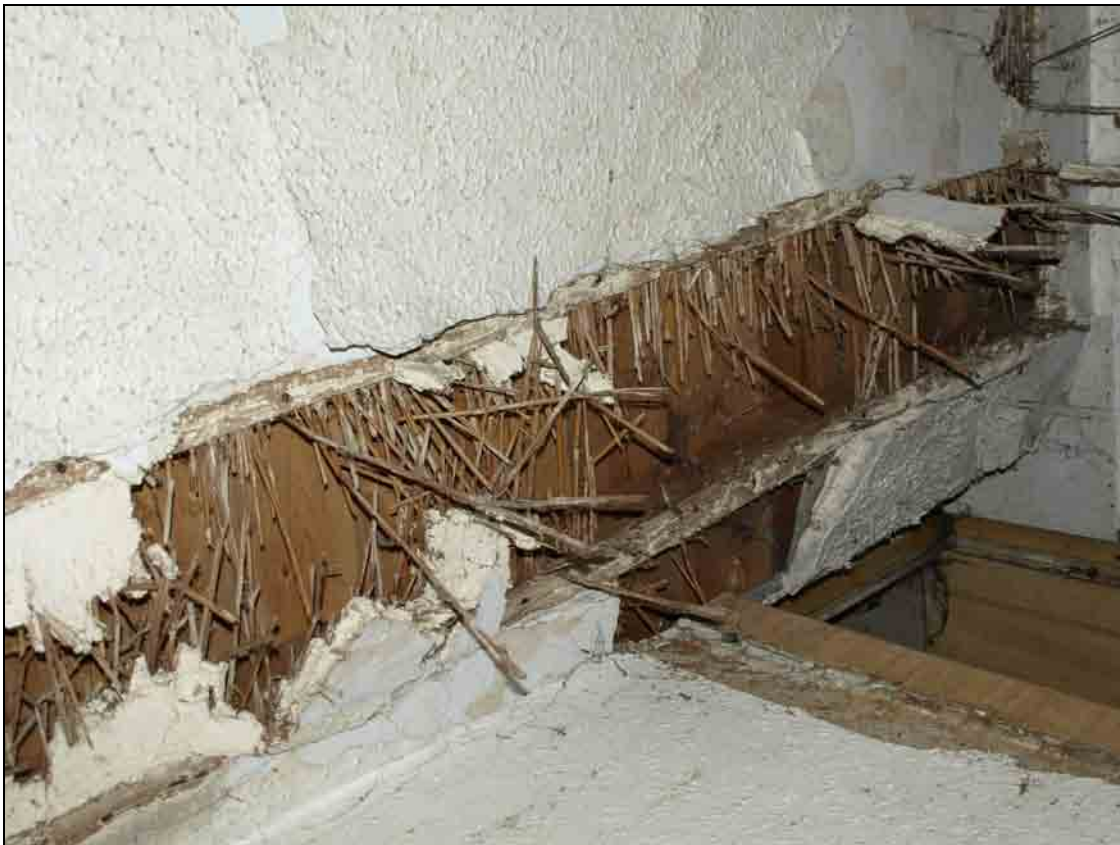
Photo 12: Building 1: detail of plaster and straw ceiling over housebody

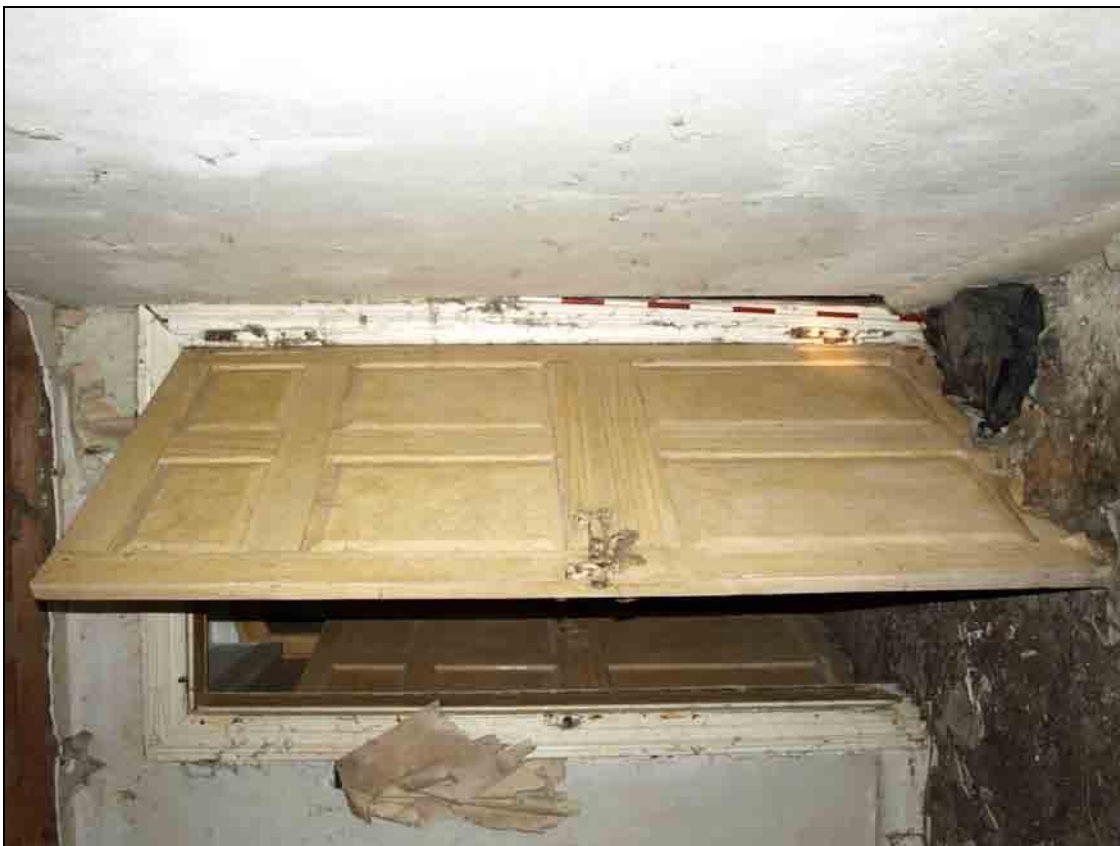
Photo 11: Building 1: six panel door to parlour

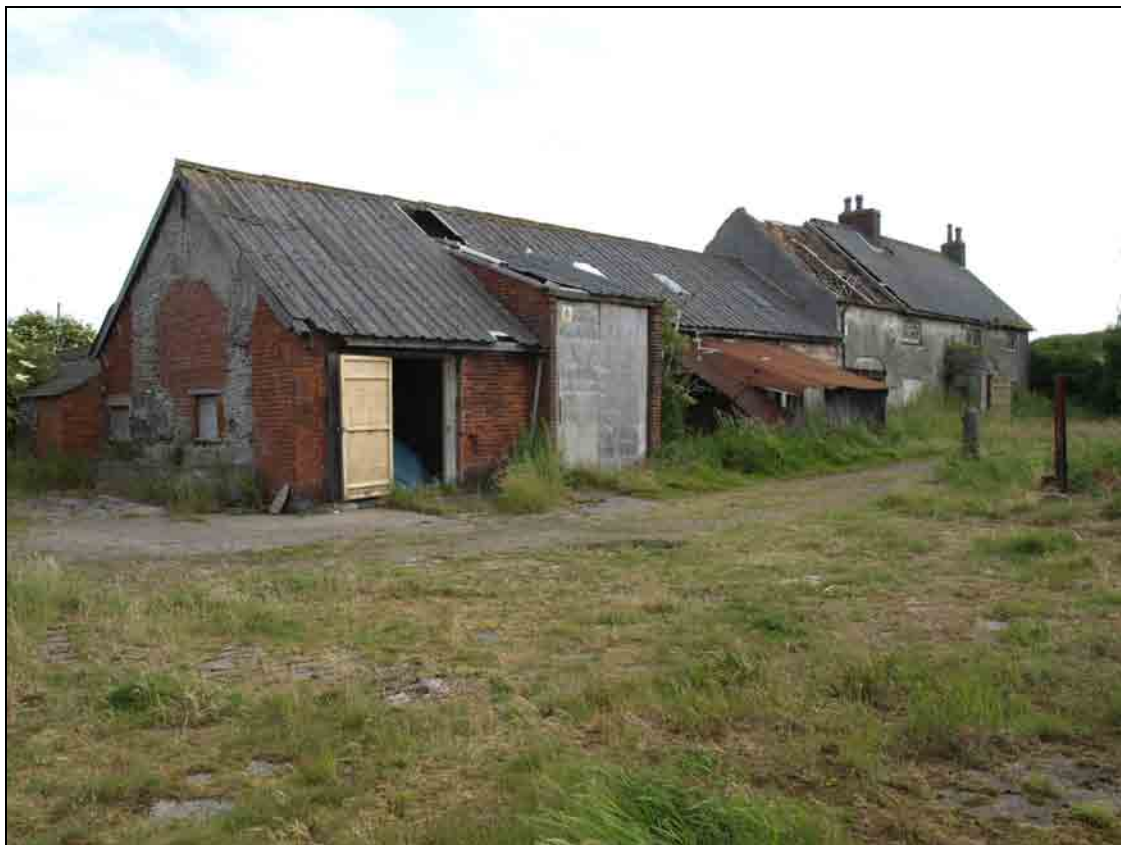
Photo 13: Buildings 1, 2 and 3: main range, from the south-west

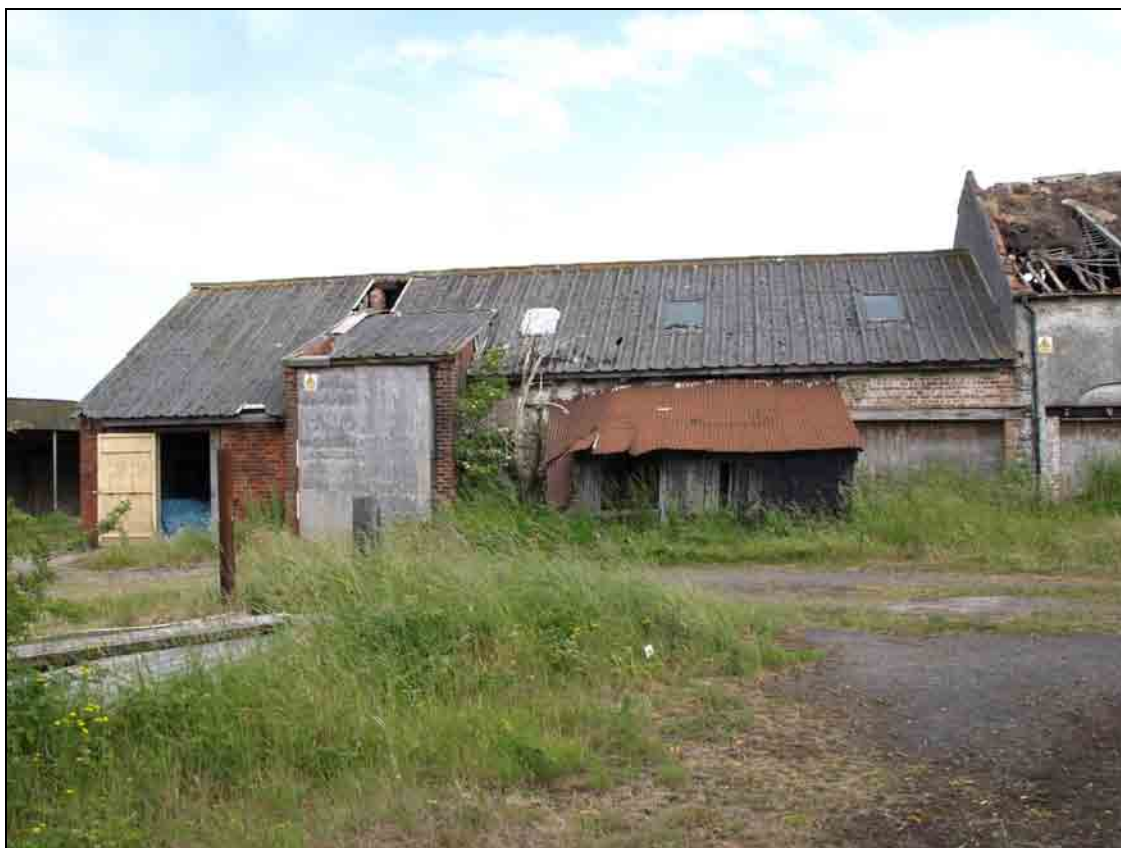
Photo 14: Building 2 and 3: barn and shippon, front elevations

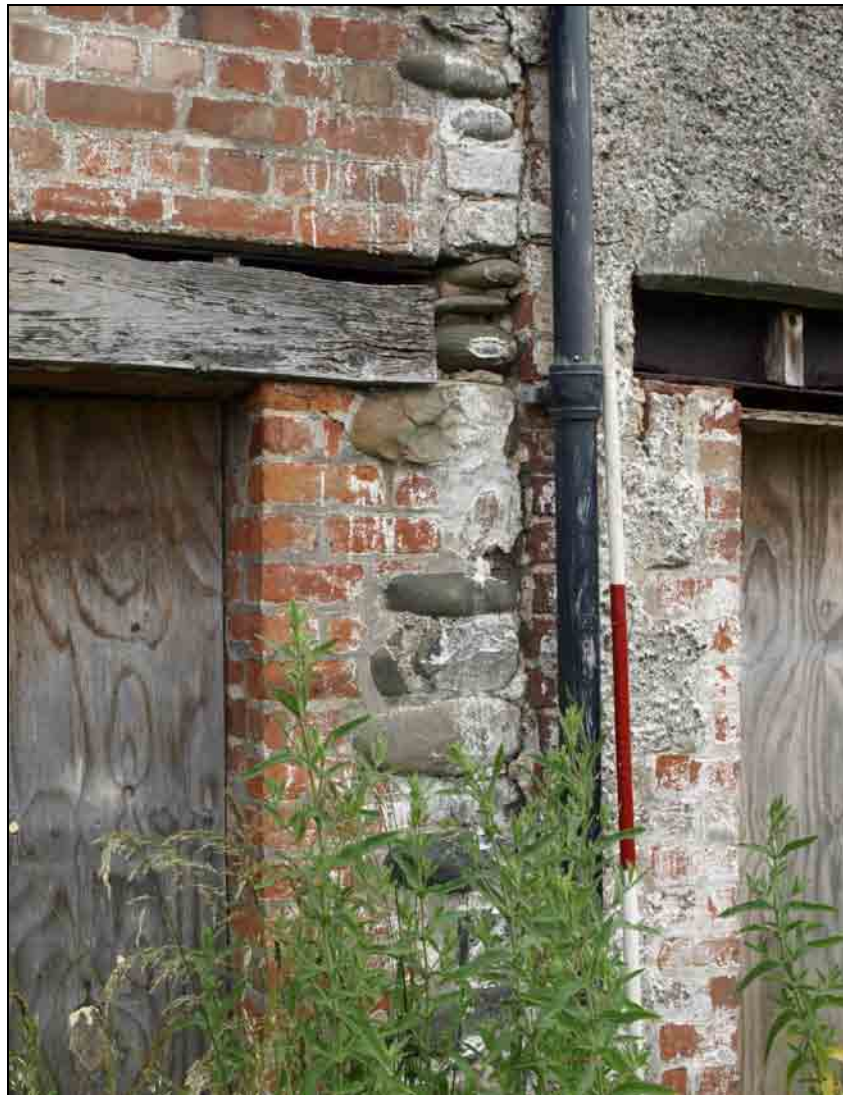
east gable seems to have been abutted by the house. However the original building has been greatly altered: the brick porch on the south side of the west bay is probably an addition, a mid 20th century cross-wall now divides the eastern third from the remainder, a modern steel truss has replaced the original between the other two bays, and the roof covering, probably also thatch at the outset, is now asbestos sheeting. It is interesting to note how the walls are thickened to provide footings for the truss.

Photo 15: Building 2: detail of butt joint between barn and house

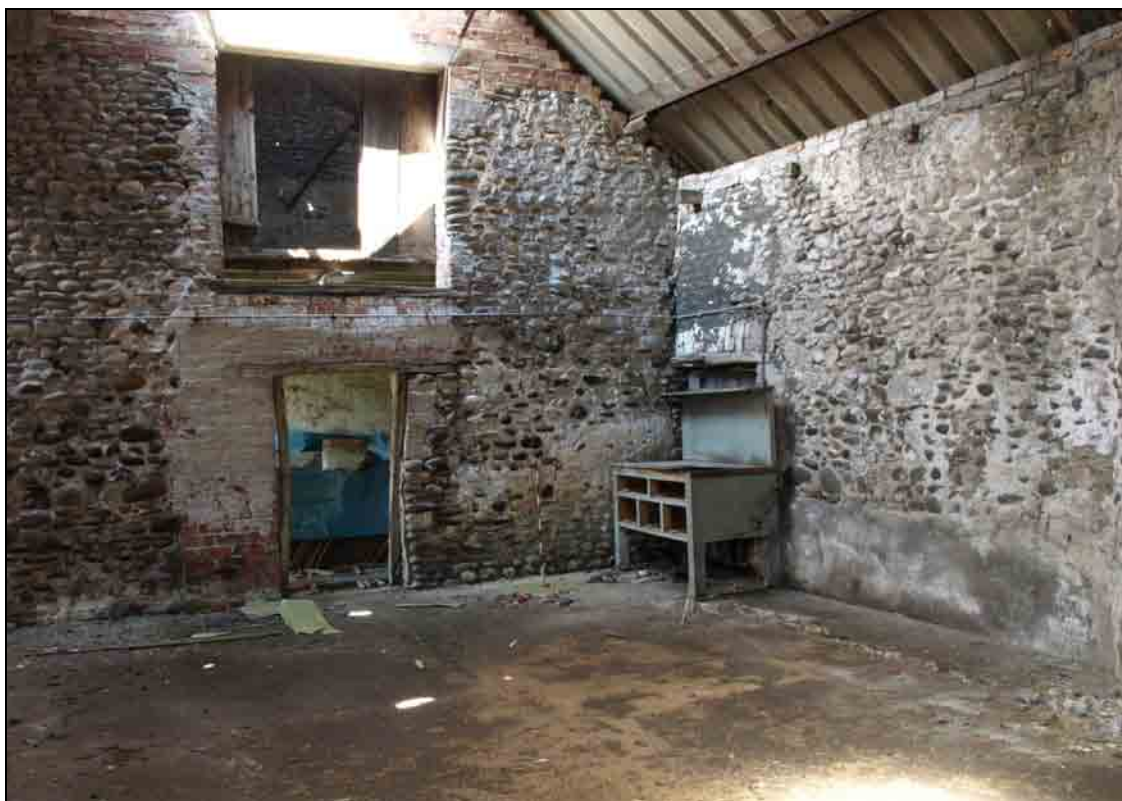
Photo 16: Building 2: interior of barn, from the north-east

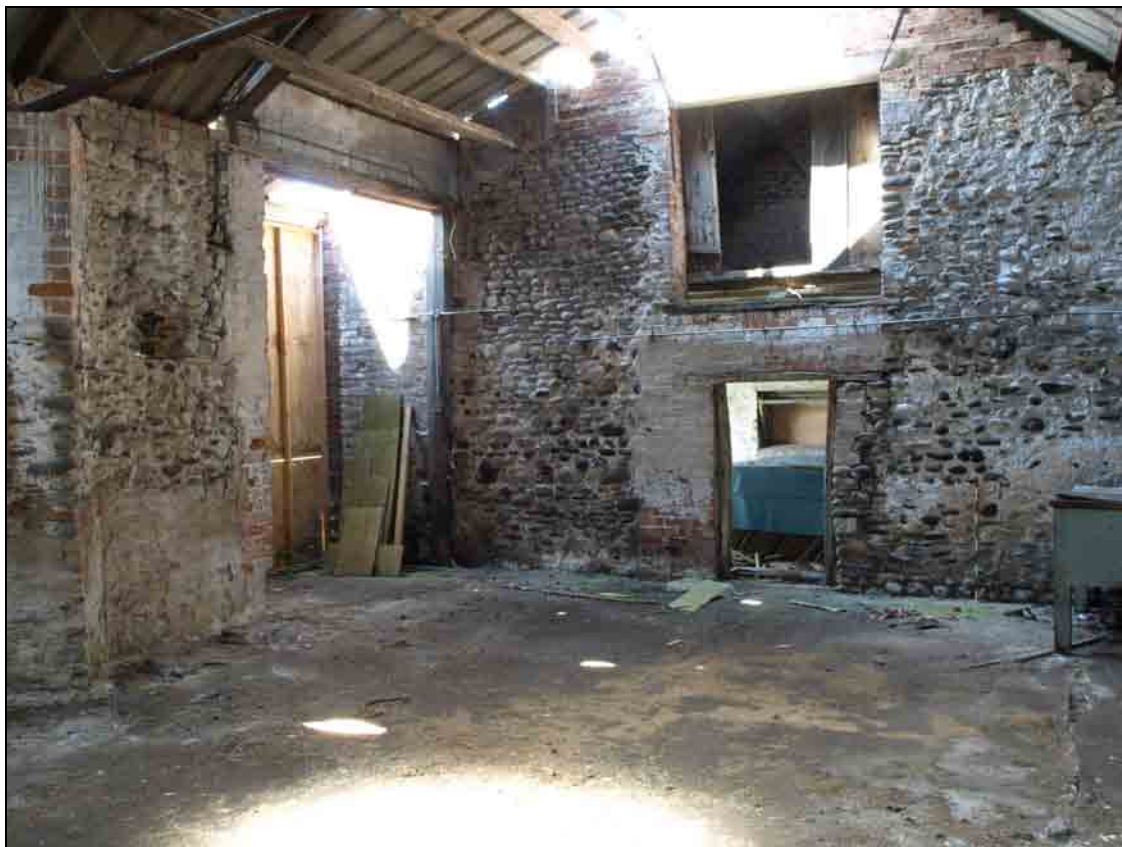
Photo 17: Building 2: interior of barn, from the south-east

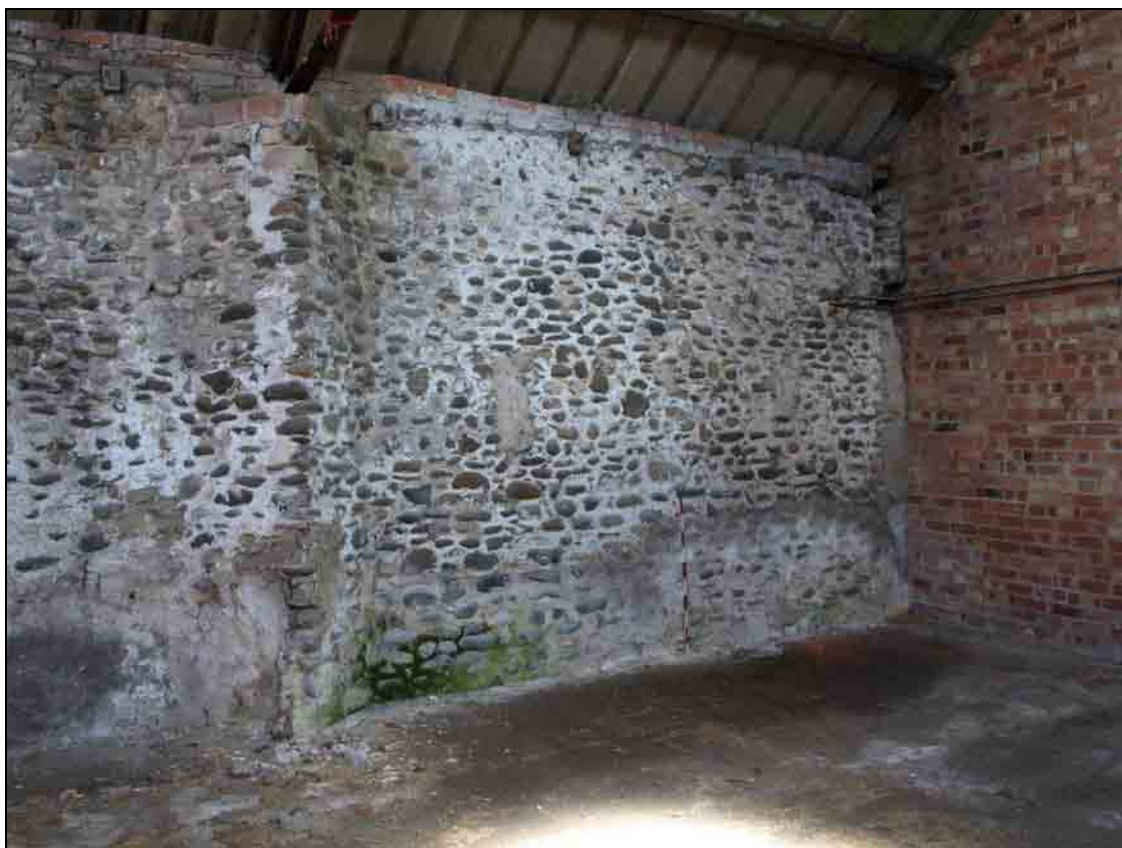
Photo 18: Building 2: interior of barn, from the south-west

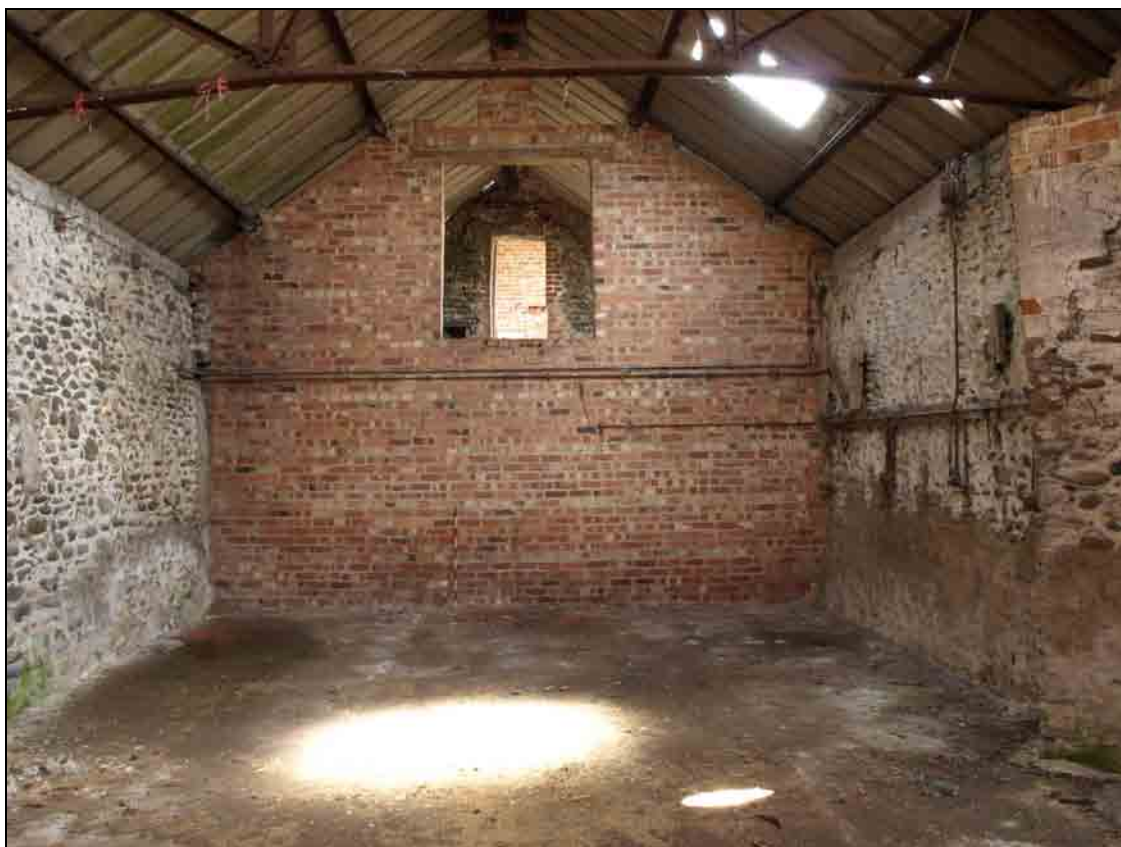
Photo 19: Building 2: interior of barn, from the west, showing modern dividing wall

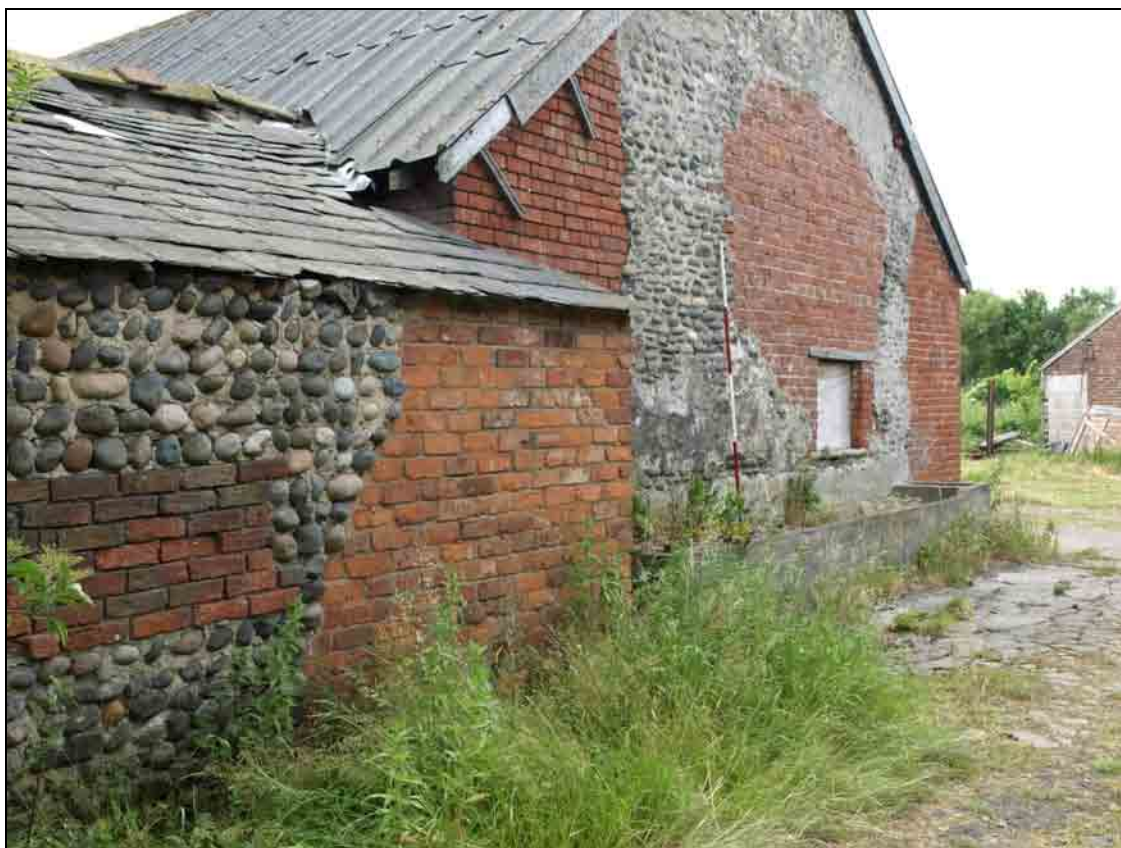
Photo 20: Building 3: shippon, west gable

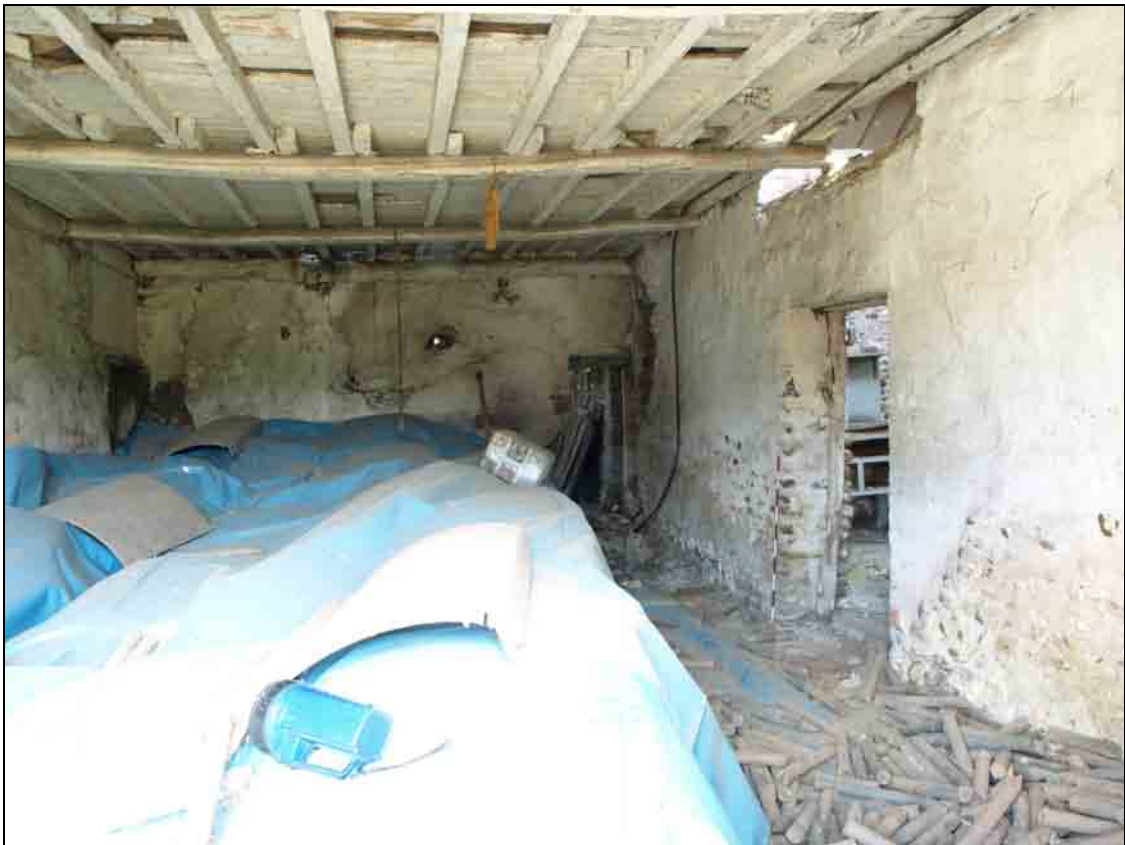
Photo 21: Building 3: shippon interior, from the south

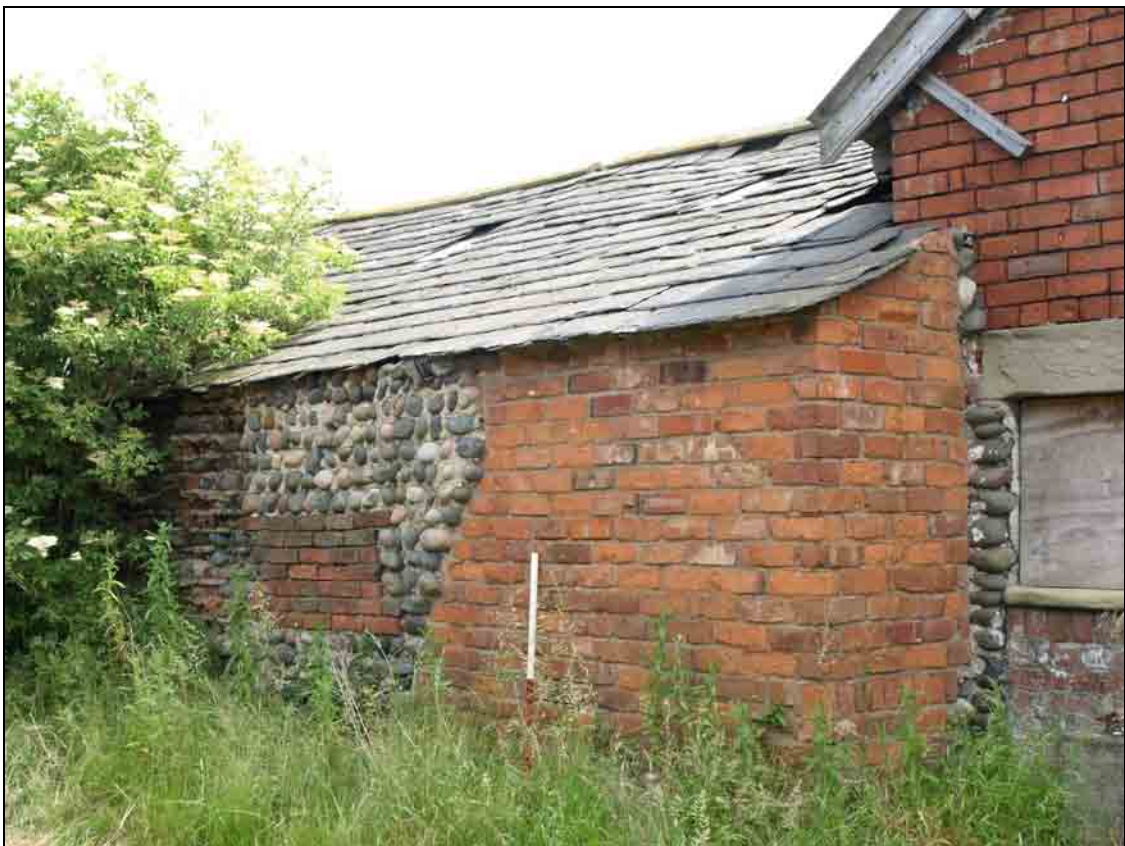
Photo 22: Building 4: shippon, west elevation

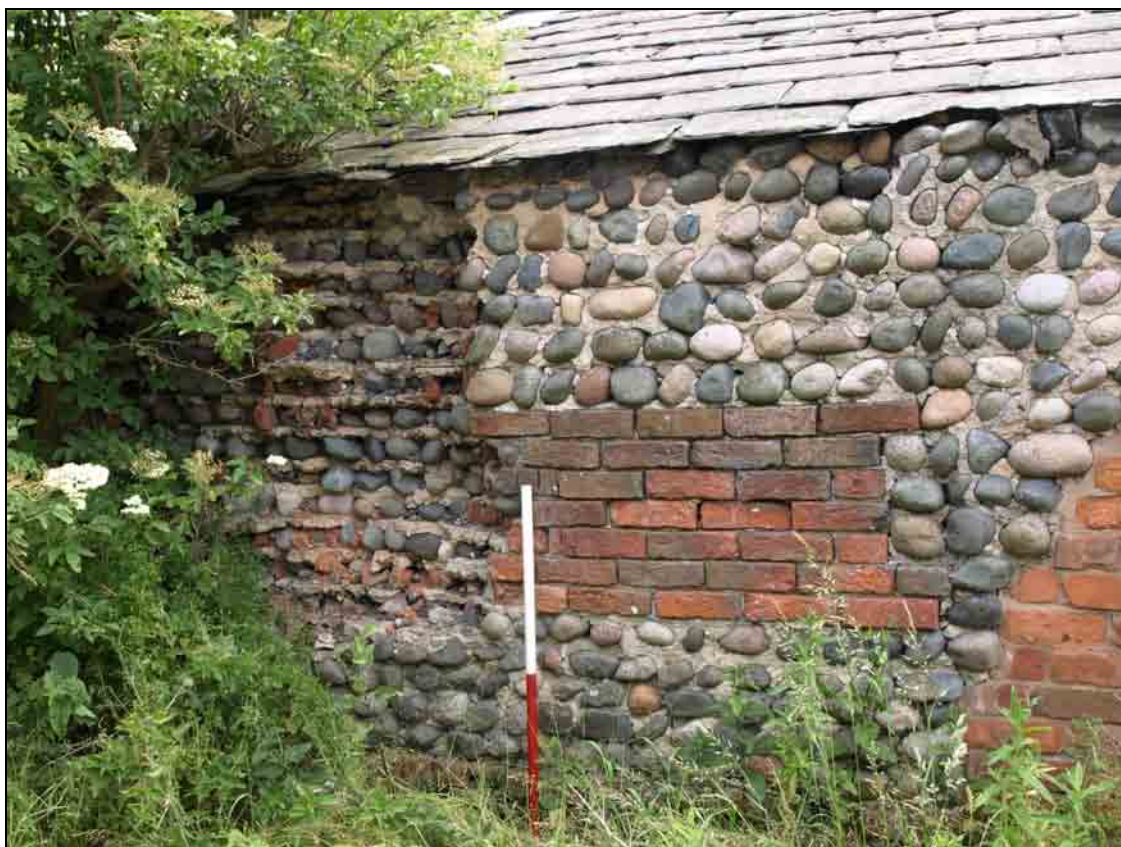
- 5.9 A second shippon was added to the north of Building 3, and maps suggest it was extant by the mid 19th century. It is also built of a mixture of bricks and cobbles, some of the walling no doubt repair rather than original fabric, and the roof is covered with blue slate and tile ridge, which imply a date no earlier than the early 19th century. Remarkably the interior appears unchanged since 1938, when it is shown with stalls for eight animals, probably young, facing onto a feeding passage, and the loose box that plan shows at the north end is still of that form. There is a single king post roof truss, of typical 19th century form.

Photo 23: Building 4: detail of brick and cobble west wall
