Midgeland Farm  
Midgeland Road, Marton, Blackpool, Lancashire:  
Historic Buildings Assessment

July 2009

### Historic Buildings Assessment

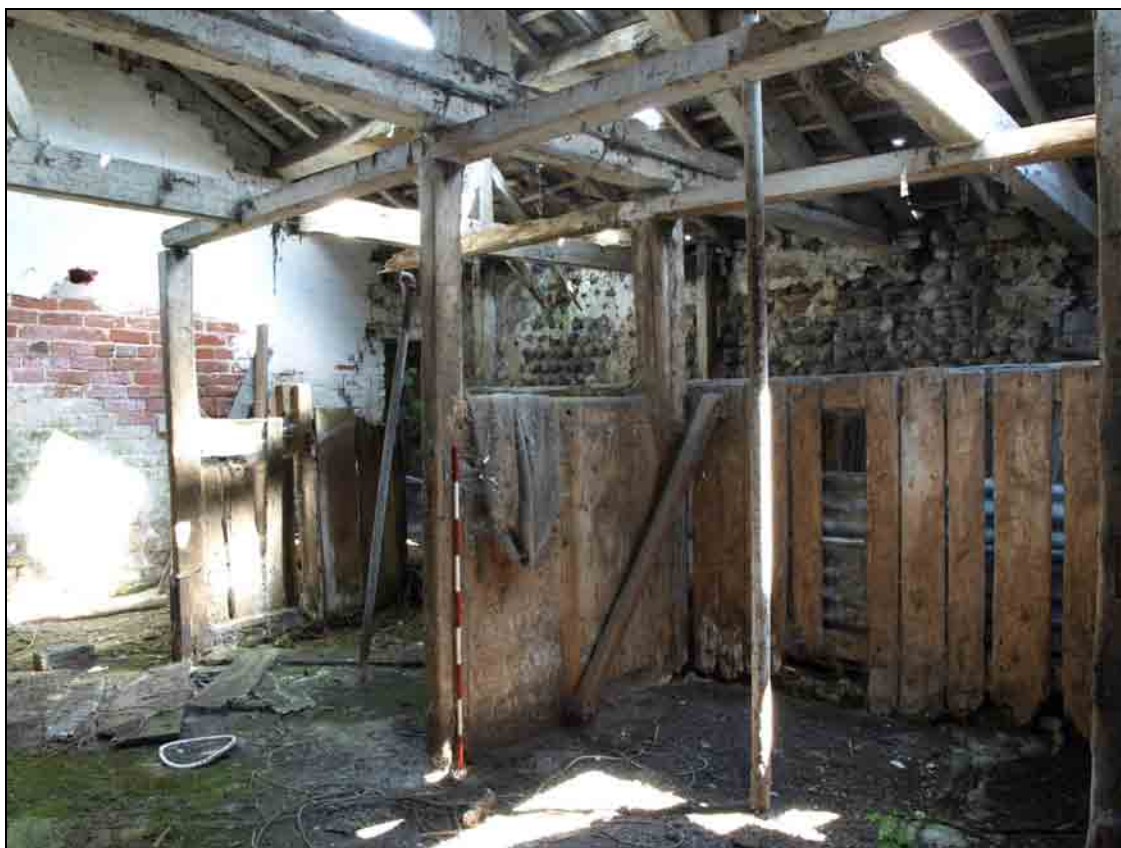
Photo 24: Building 4: interior of shippon, from the south-west

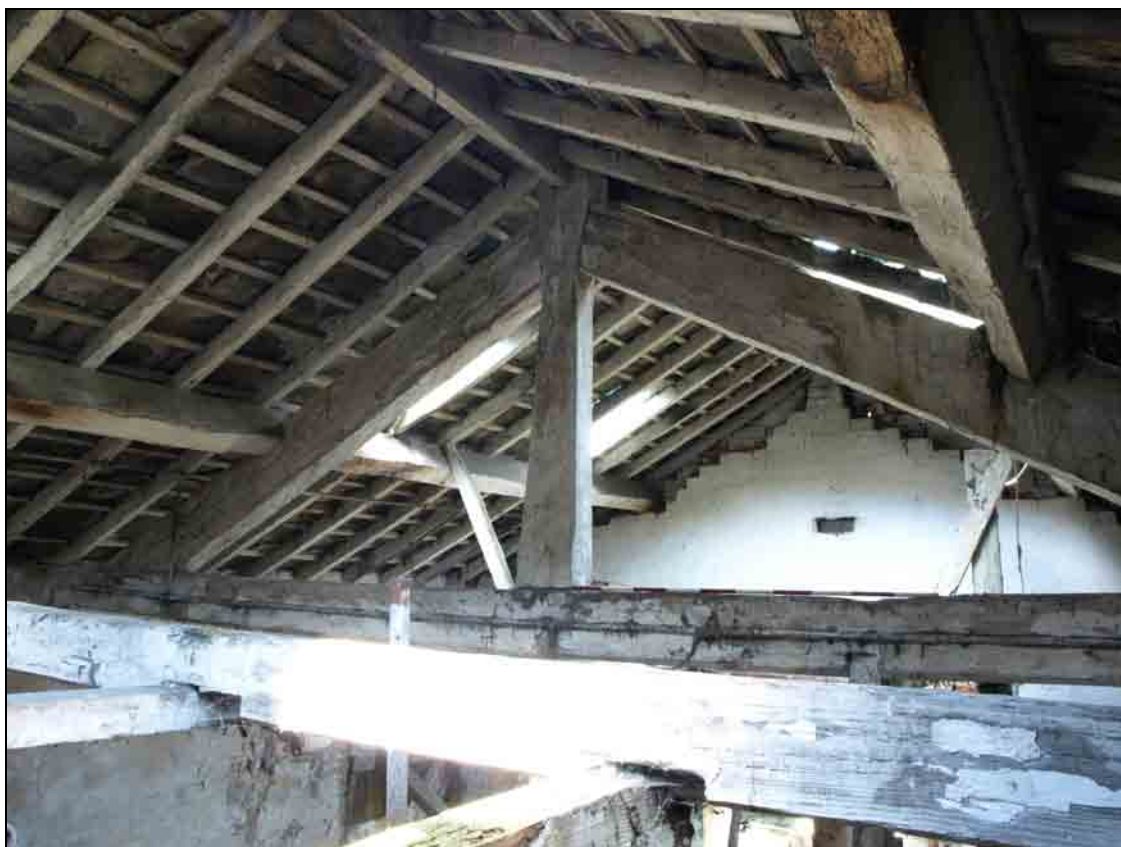
Photo 25: Building 4: roof truss in shippon, from the south-east

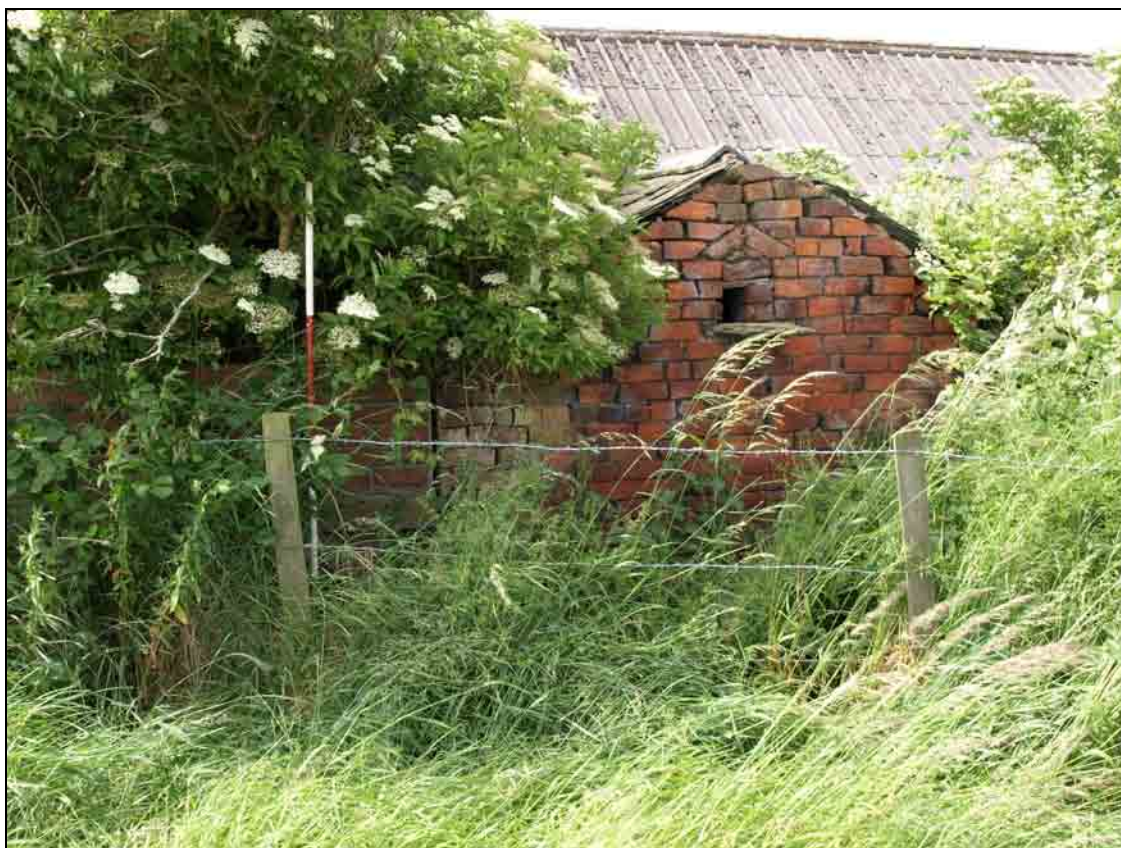
Photo 26: Building 5: north side of pig sties

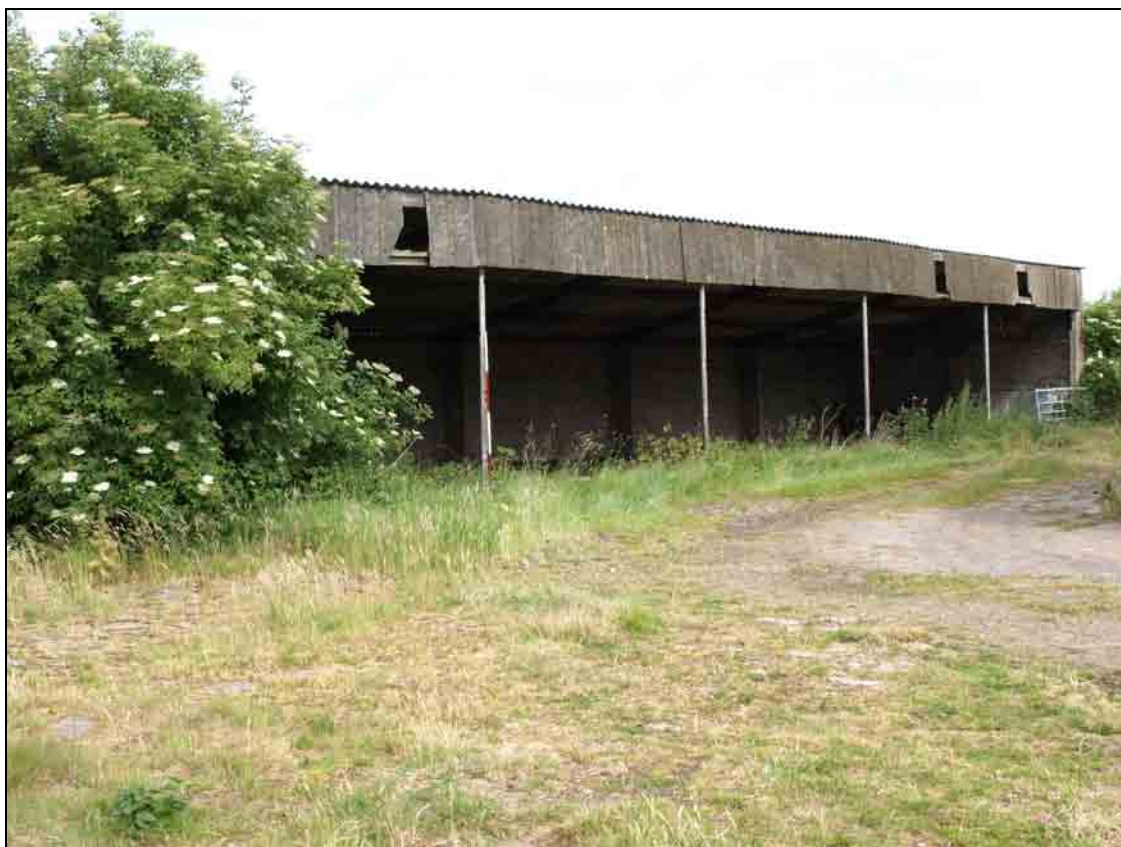
- 5.11 This long, open-fronted shed is probably mid 20th century but may incorporate parts of an earlier structure, although if so they would be no earlier than the 1890s as this area was not built on in 1891. It is not of interest.

Photo 27: Building 6: modern implement shed, from the east

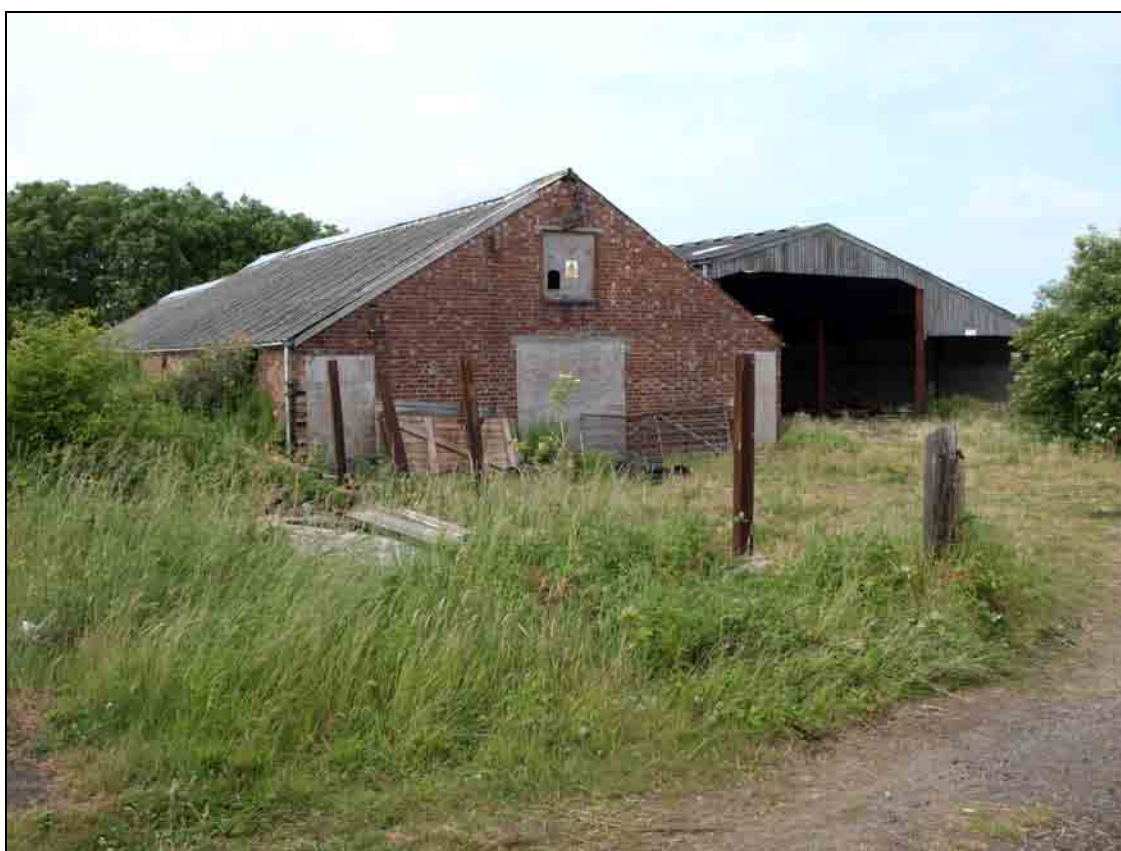
Photo 28: Buildings 7 and 8: mid 20th century shippon and late 20th century Dutch barn
