**PROPOSED MARTON MOSS CONSERVATION AREA**

**CONSERVATION AREA APPRAISAL**

**AUGUST 2018**

**Blackpool Council**

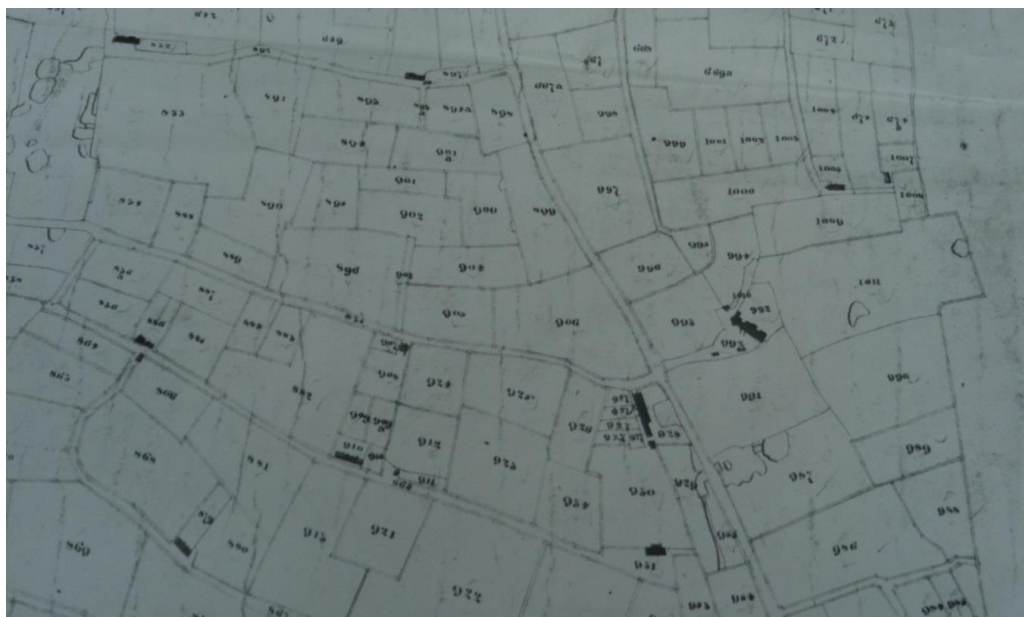
Extract from 1839 tithe map. Midgeland Farm is set in the middle of field 992

- 6.4 Locally listed Midgeland Farm was probably originally completely cobble built and, in its rural setting, is the least compromised of the Marton Moss historic buildings. The current farmhouse is probably early 19<sup>th</sup> century re-constructed from handmade brick, with earlier attached cobble built barn and shippens with brick patch repairs. Unlike other 'improved' farmhouses, which were usually roofed in slate, Midgeland retains its thatched roof under the damaged asbestos sheeting, which suggests it was one of the earlier sites to be altered. The farmhouse sits on the edge of a former landfill site owned by Lancashire County Council, and is currently in a dilapidated state. It is surplus to Lancashire County Council's requirements and potentially at risk of demolition.

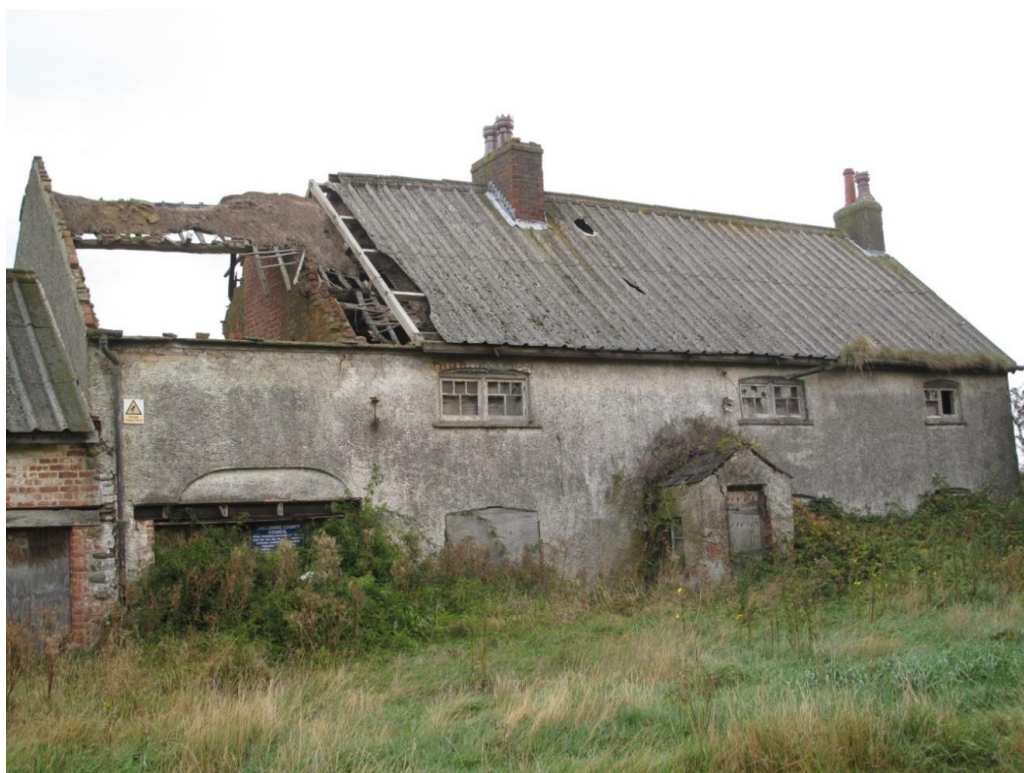
Locally listed Midgeland Farm in an advanced state of disrepair

- 10.1 The cobbled buildings which were once so common in this area are now few in number. Midgeland Farm is a locally listed building which has been allowed to fall into decay. Its repair and conservation should be seen as a high priority as it is one of the key historic buildings in the area.

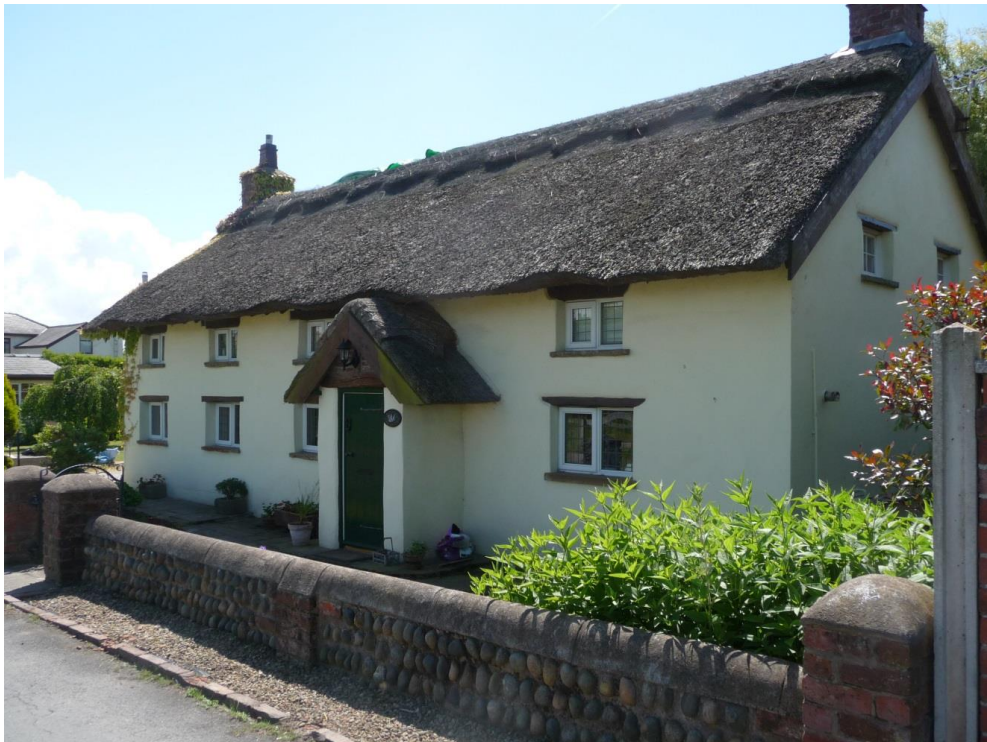
**Butcher's Farm Cottage, Worthington Road**

- 6.6 The locally listed Butcher's Farm Cottage on Worthington Road is late 19<sup>th</sup> century but maintains the Moss tradition of thatched roof covering.

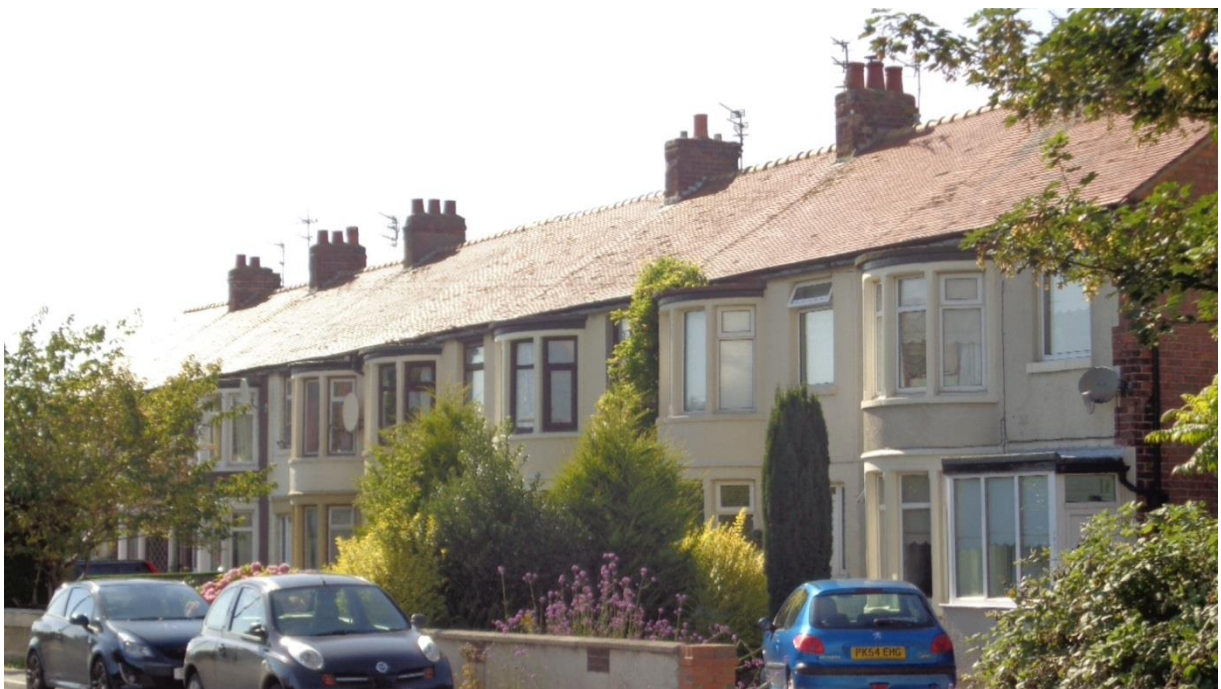
Nos. 181 – 195 School Road

- 6.11 The terrace to the east of St. Nicholas primary school close to the intersection was built c. 1935 and is a typical design of the period with double height curved bay windows. The front elevation is rendered and painted, and the red tile roof covering makes an attractive contribution to the streetscene, although some of the boundary walls have been removed which undermines the uniformity of the terrace.

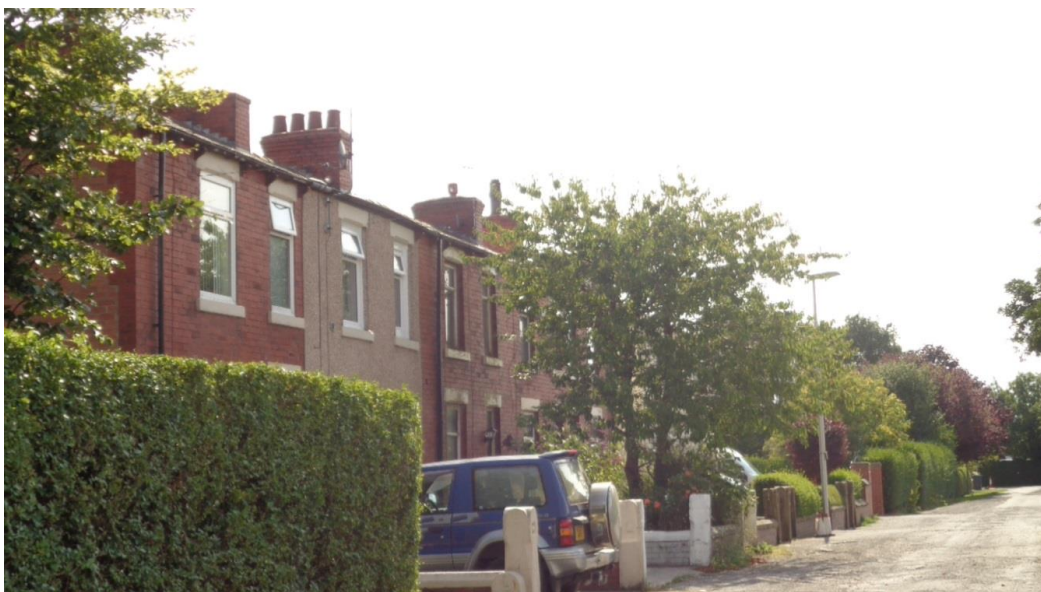
**Terraced housing on Laundry Road**

- 6.18 The south side of Laundry Road has limited late Victorian development in the form of terraced housing, and a handful of detached dwellings where it turns north, together with some glasshouses.

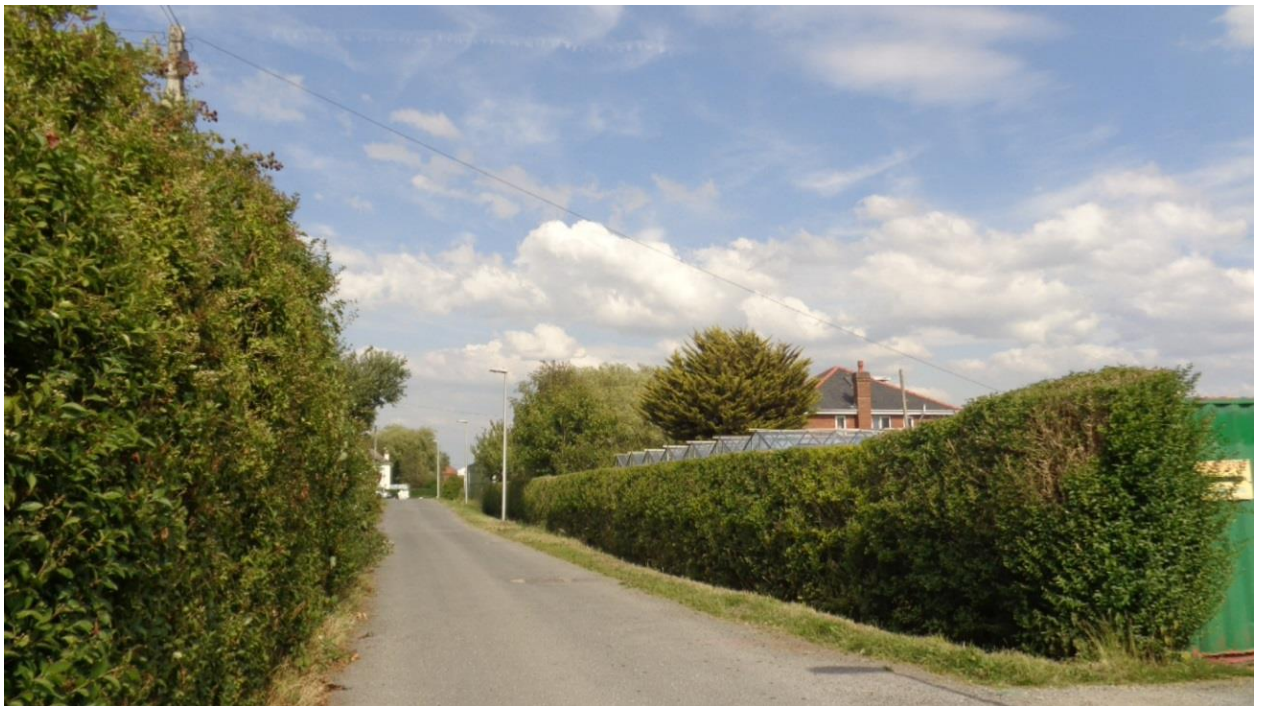
- 6.19 New Hall Avenue is given over largely to glasshouses to the south with a few detached dwellings where it turns to the north. This lane also has an enclosed feel being lined with hedgerows.

**Glasshouses visible behind the hedge on New Hall Avenue**

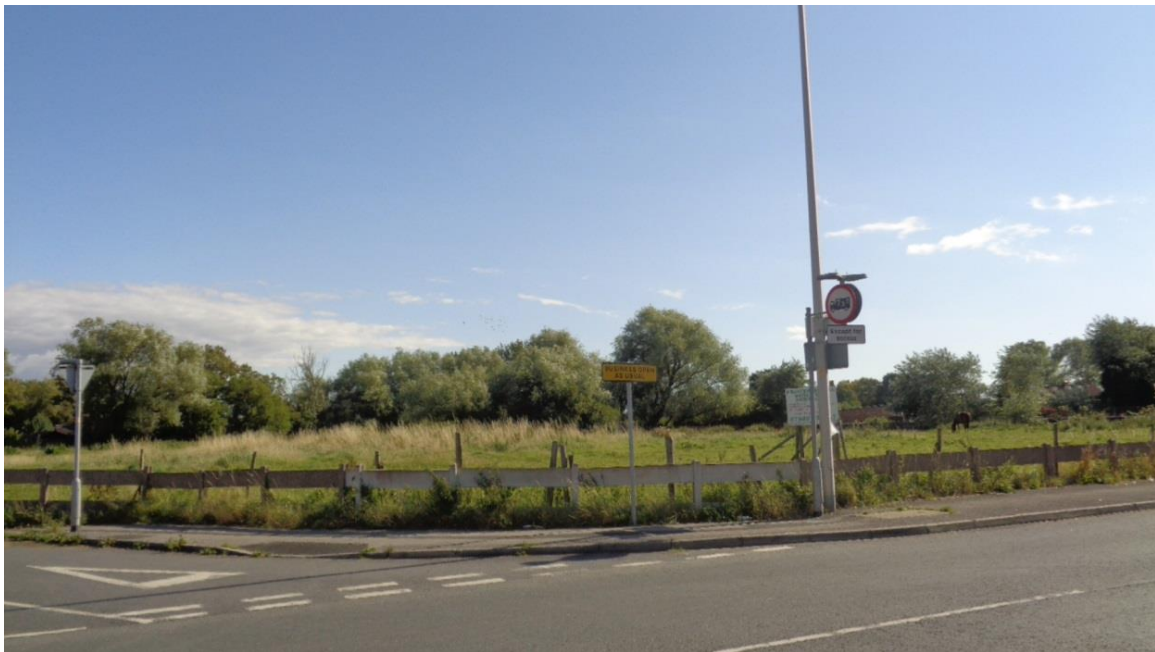
- 8.1 The majority of the boundaries in the area are formed by hedgerows which line the roads and lanes.
- 8.2 The open land at the intersection with School Road has a variety of boundary treatments. The south west paddock is surrounded by timber fencing whilst the paddock to the north east has concrete railing which is missing in places.

Timber fencing to south west paddock

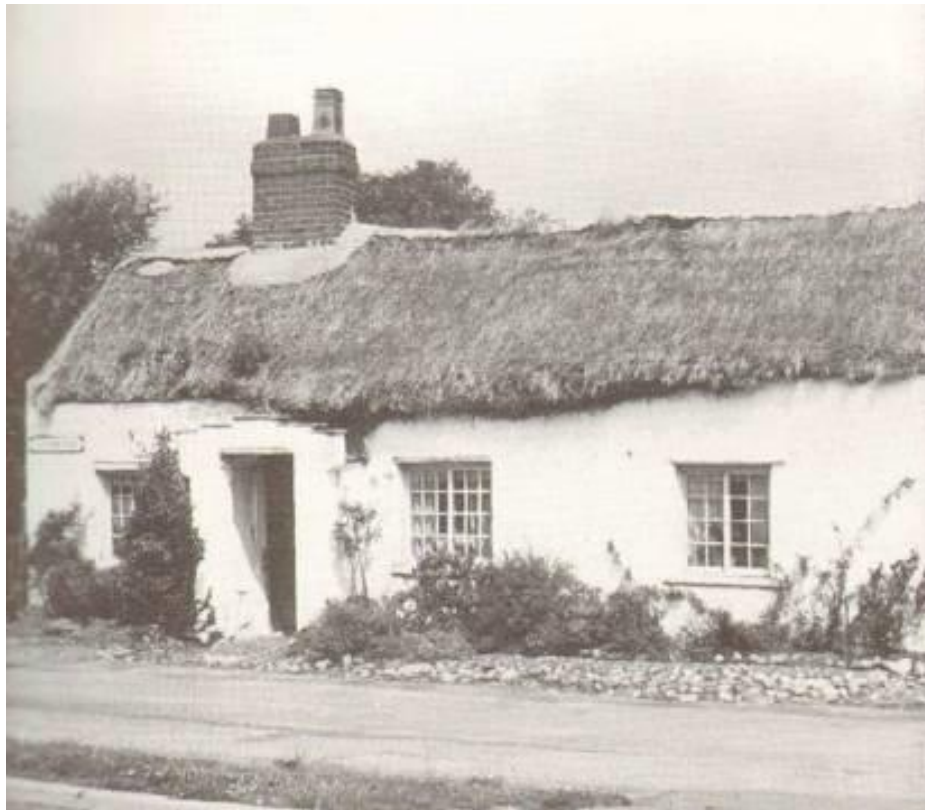
**Typical Fylde longhouse, now demolished**
